Figure Title	
Peat Landslide Hazard and Risk Assessment: Contributory Factors - Drainage (D)	
Project Name	
M74 West Renewable Energy Park	
Project Number	Figure No.
1620015684	8.3.7e
Date	Prepared By
August 2024	BE
Scale	Issue
1:22,500 @A3	1
Client	
M74 West Ltd

Figure Title Peat Landslide Hazard and Risk Assessment: Contributory Factors - Forestry (F)	
Project Name M74 West Renewable Energy Park	
Project Number 1620015684	Figure No. 8.3.7f
Date August 2024	Prepared By BE
Scale 1:22,500 @A3	Issue 1
Client M74 West Ltd

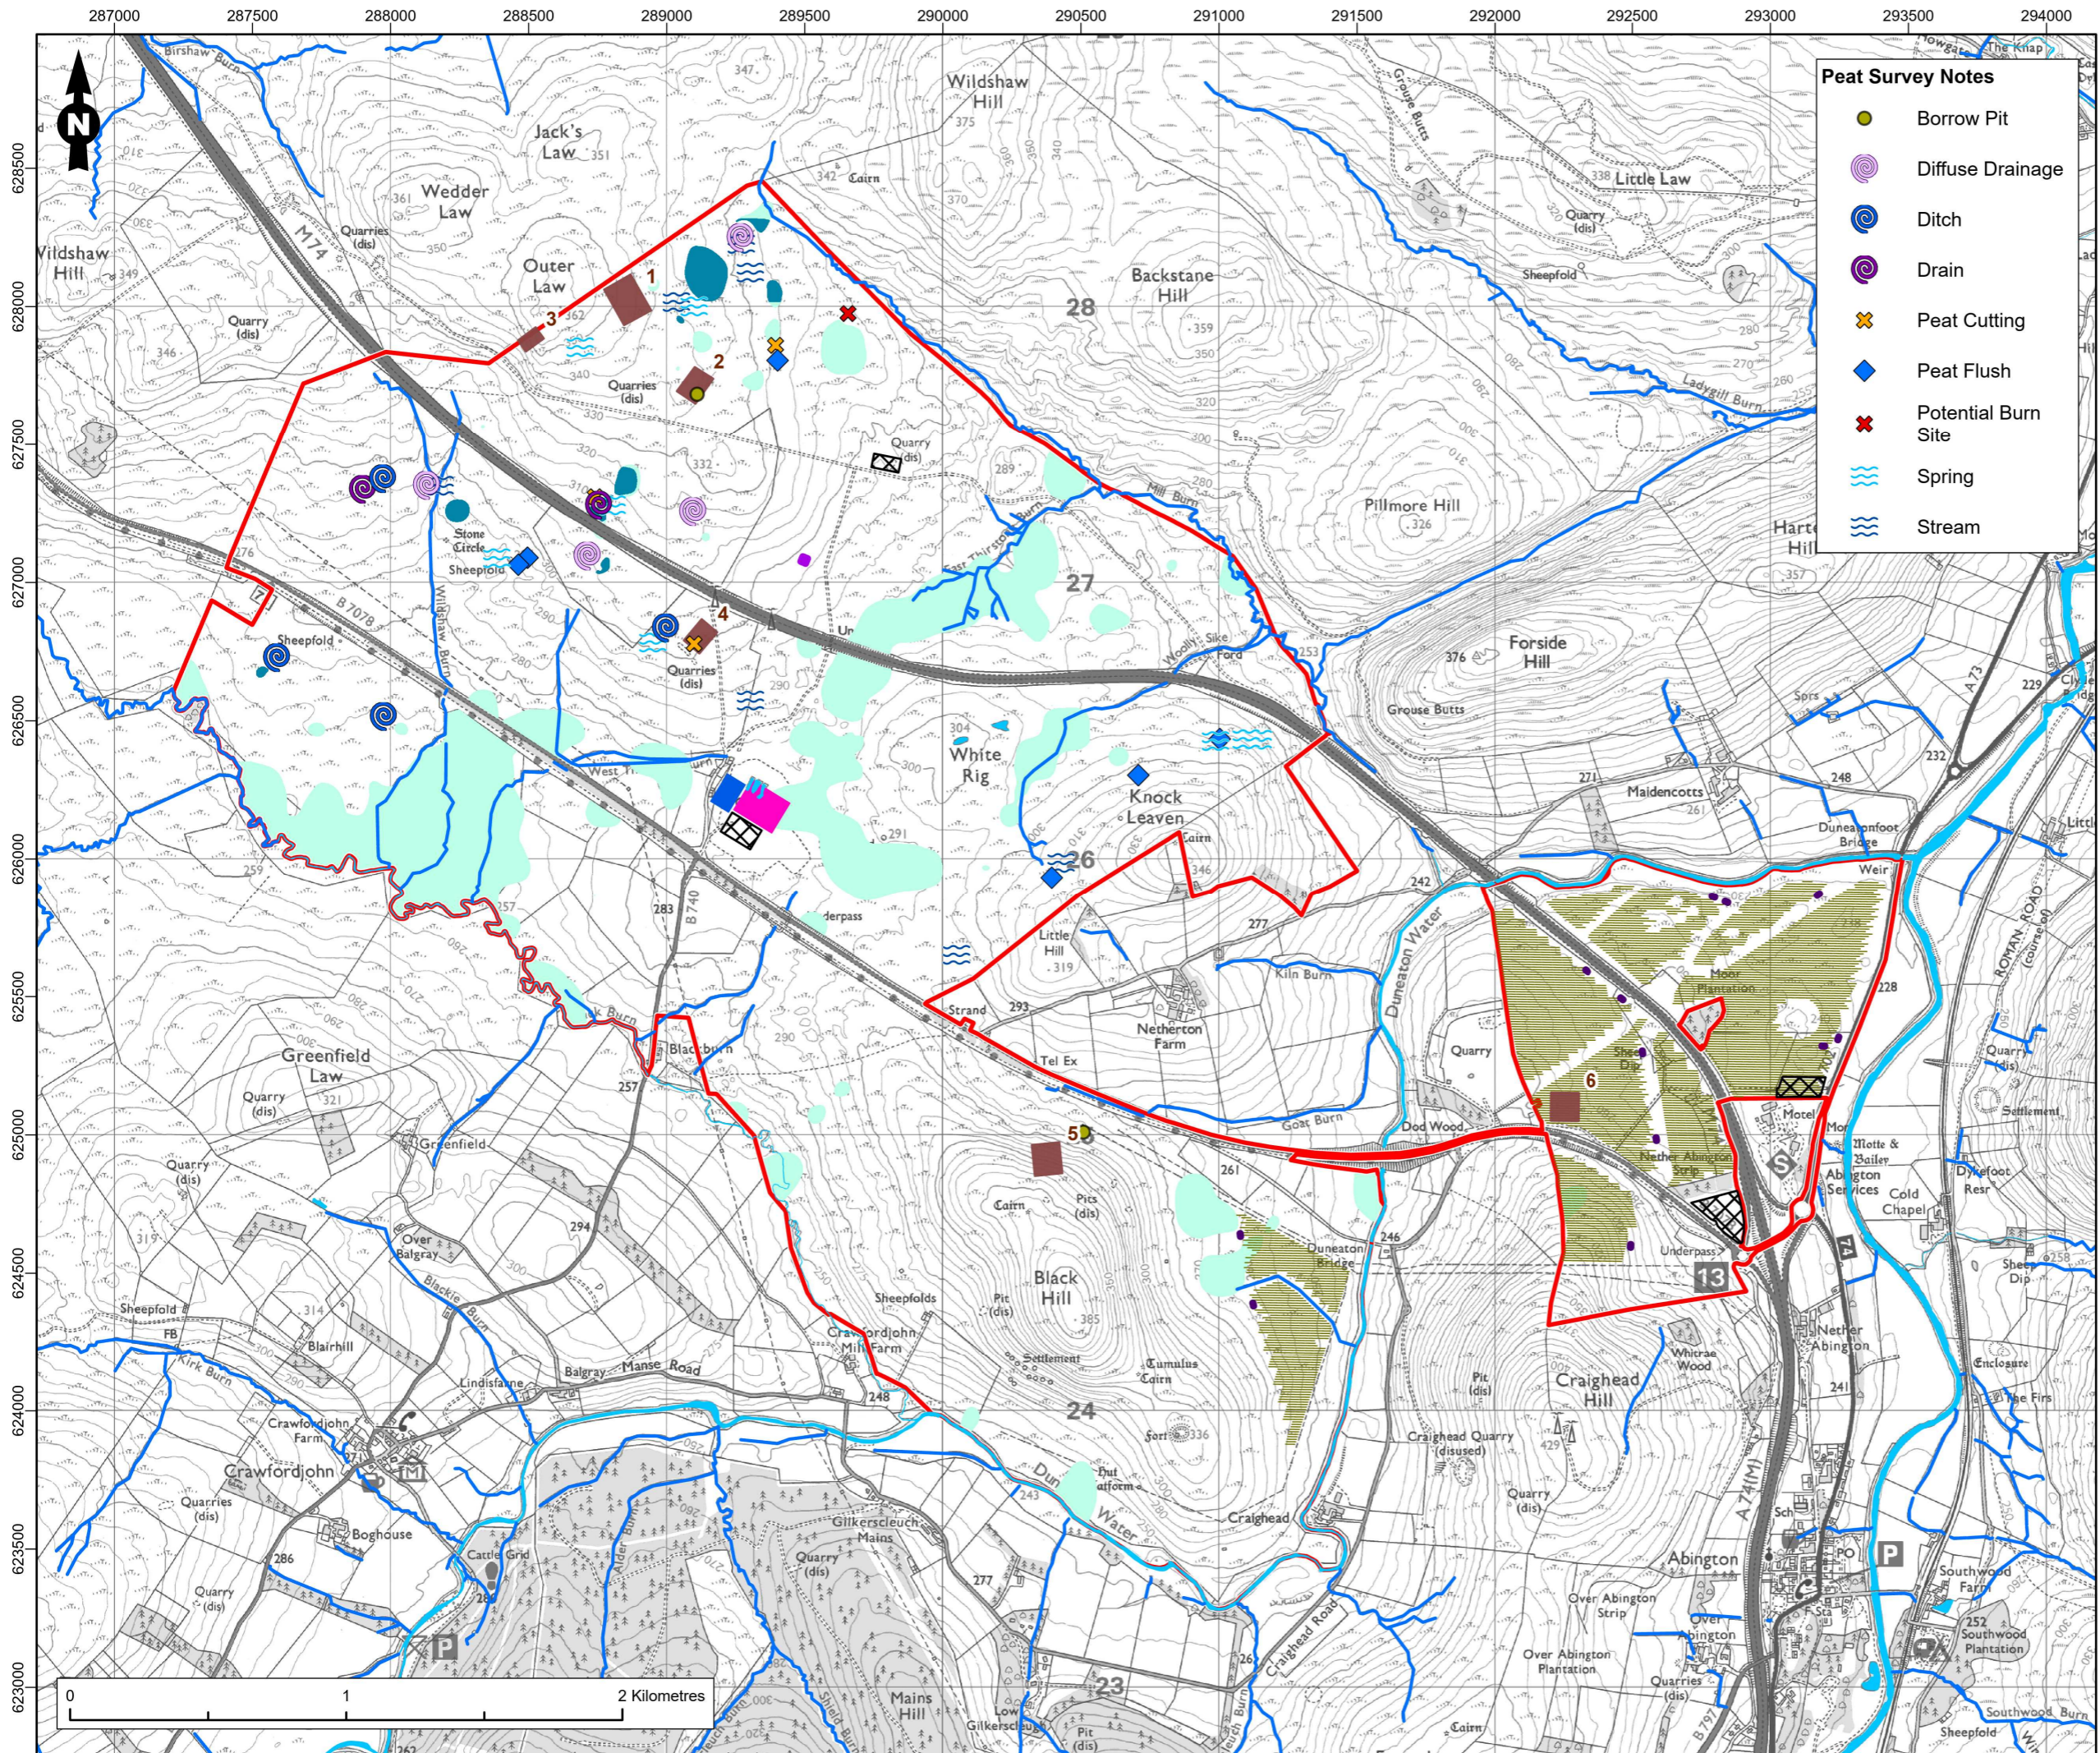
Drainage Scores (D)

- Score 0: No Drainage Lines
- Score 1: Drain Aligned to Slope
